**Lower Butte Creek - Sutter Bypass
Weir No. 2 Fish Passage Project**

**Preliminary Engineering
Technical Report**

December 2003

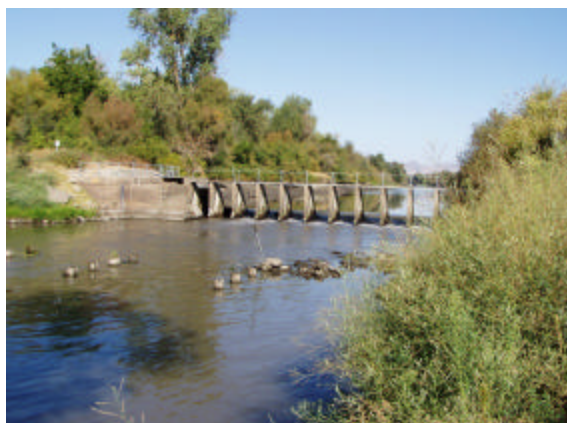
Figure 10. Weir No. 2 dewatering

hole became apparent when the survey crew was recording elevations of the apron and discovered a void where the elevation was much lower than the surrounding apron. The hole was estimated to be about 5 to 6 feet deep and 1 to 2 feet in diameter. The finding was reported to DWR SMY staff. This caused concern because the void in the foundation of the existing weir structure is becoming large enough to extend to the piers of the structure which will ultimately result in failure of Weir No. 2.

Another reason for concern was that a current meter measurement (CMM) performed immediately downstream of Weir No. 2 and a weir calculation performed at the same time on July 10, 2001, resulted in a discrepancy of about 40%. The CMM was 125 cfs compared to the weir flow of 76 cfs. The 49 cfs of unaccounted for water past the weir structure is not likely to occur strictly through the flashboards. It is thus assumed that the difference between the actual measurement and weir flow plus flashboard leakage is the water leaking under the Weir No. 2 foundation. A second CMM and weir flow calculation was conducted on August 14, 2002, and resulted in a discrepancy of 18% (165 cfs CMM/136 cfs weir flow), or 29 cfs, which is not likely to occur strictly through the flashboards. The leakage occurring under the Weir No. 2 foundation could lead to more undermining and ultimately failing.

An evaluation of the structure by the DWR-DOE, Structure Section was requested in August 2002. In September 2002, Weir No. 2 was partially dewatered by DWR SMY staff (Figure 9). This allowed an evaluation to assess the condition of the existing structure (Figure 10). The structural evaluation concluded that significant wear has occurred to the concrete apron of the structure. The concrete apron is worn to the point that three holes exist exposing the underlying soil. A hole exists in the downstream cutoff wall along with an adjacent void, indicating seepage is eroding the soil directly below the apron. Appendix C contains the memorandum summarizing the results of the Weir No. 2 structural evaluation.
