**Lower Butte Creek - Sutter Bypass
Weir No. 2 Fish Passage Project**

**Preliminary Engineering
Technical Report**

December 2003

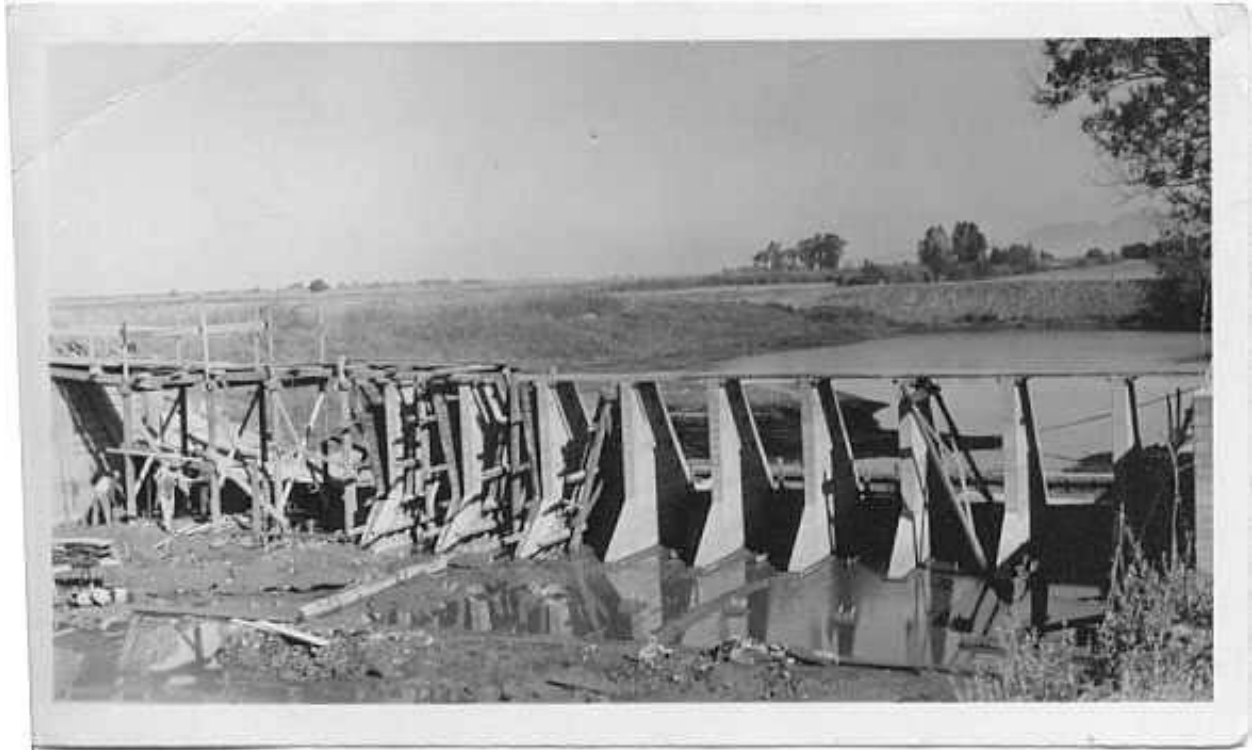
Figure 2. Weir No. 2 rebuilt in 1946 (looking upstream)

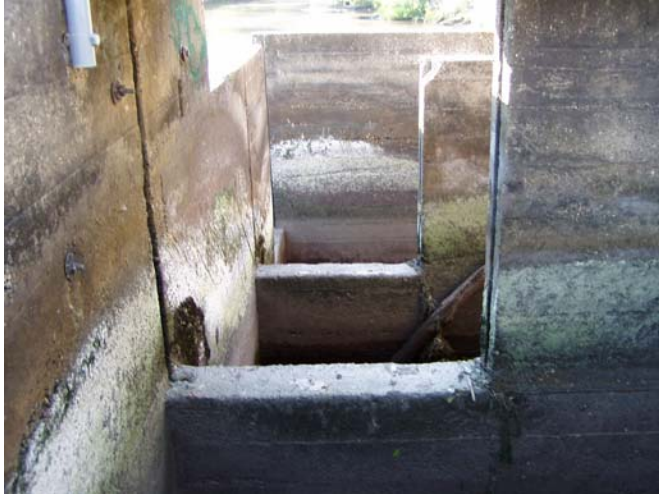
The objective of this project is to reduce losses of adult and juvenile anadromous fish from the Lower Butte Creek system. The existing weir and fish ladder structures have been in place for more than 50 years and are outdated. The existing pool and weir fish ladder does not meet today's standards for fish ladders and its entrance is poorly oriented to spills over Weir No. 2 (Figure 6). Passage is difficult at best with the existing ladder due to its low flow capacity and lack of sufficient steps. Water surface differences between pools are commonly around 2 feet.

Figure 4. Rectangular weir of the existing pool and weir fish ladder

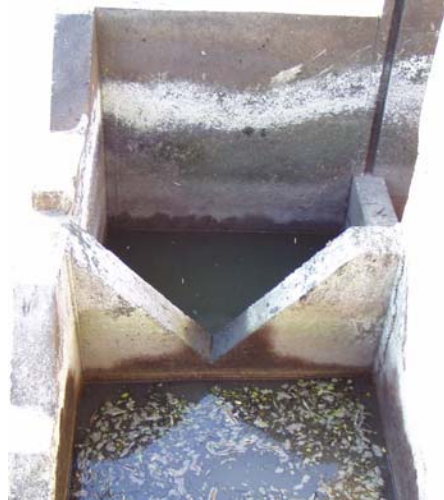
Figure 5. V-notch of the existing pool and weir fish ladder

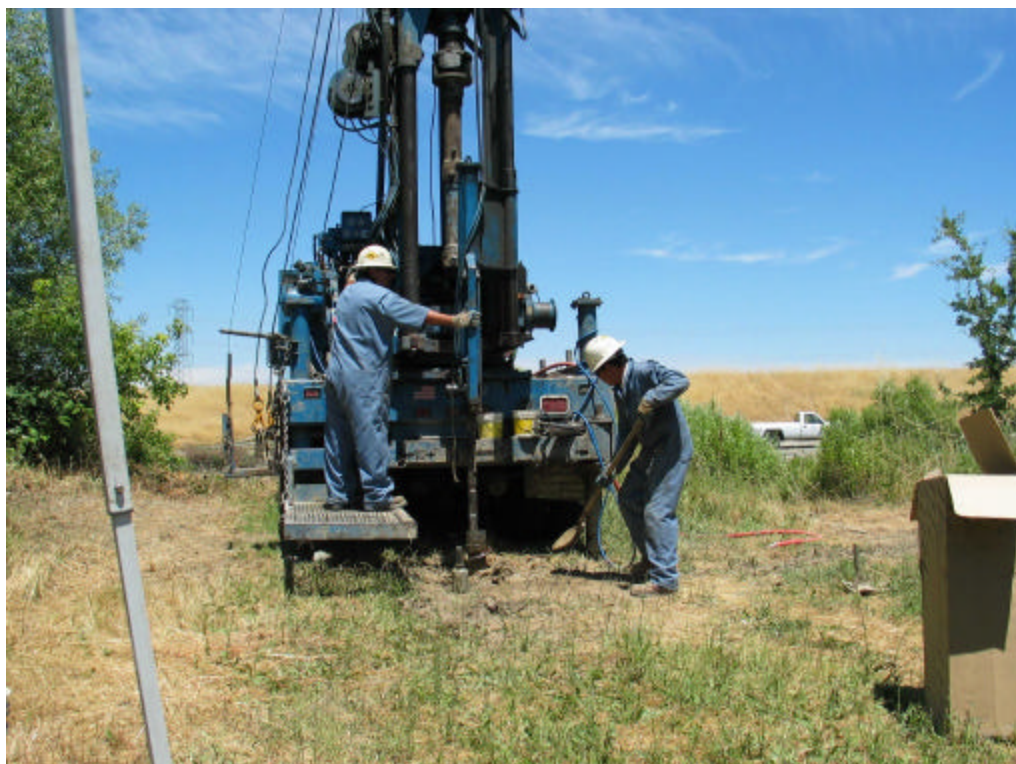
DWR-DOE Project Geology staff performed geologic exploration to collect specific subsurface geological data to be used in the final design of the foundations for the new weir and fish ladder. The exploration work consisted of 2 auger holes drilled to a depth of 60 feet on each side of the existing weir structure (Figure 8). Soil classification and Standard Penetration Test blow-counts were recorded during the

Figure 9. Auger drilling on the west bank of Weir No. 2

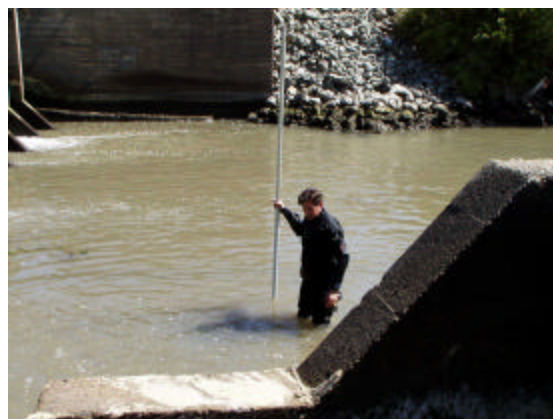
hole became apparent when the survey crew was recording elevations of the apron and discovered a void where the elevation was much lower than the surrounding apron. The hole was estimated to be about 5 to 6 feet deep and 1 to 2 feet in diameter. The finding was reported to DWR SMY staff. This caused concern because the void in the foundation of the existing weir structure is becoming large enough to extend to the piers of the structure which will ultimately result in failure of Weir No. 2.

An evaluation of the structure by the DWR-DOE, Structure Section was requested in August 2002. In September 2002, Weir No. 2 was partially dewatered by DWR SMY staff (Figure 9). This allowed an evaluation to assess the condition of the existing structure (Figure 10). The structural evaluation concluded that significant wear has occurred to the concrete apron of the structure. The concrete apron is worn to the point that three holes exist exposing the underlying soil. A hole exists in the downstream cutoff wall along with an adjacent void, indicating seepage is eroding the soil directly below the apron. Appendix C contains the memorandum summarizing the results of the Weir No. 2 structural evaluation.

Figure 11. Evaluating the downstream apron
